EVALUATION OF MANAGEMENT
REQUIREMENTS 2009

COPSE WOOD

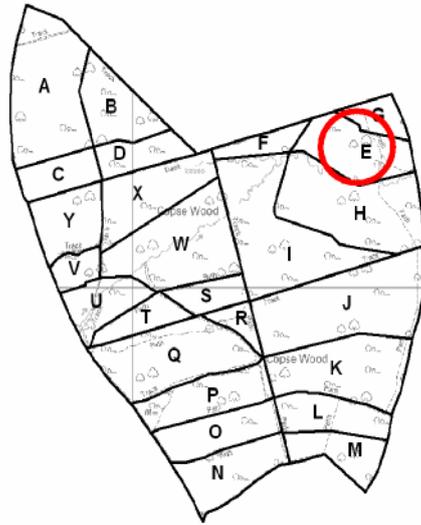
Compartment E

Description: Uneven-aged well-spaced oak and birch with a dense bracken cover with a stream forming the southern boundary. Bluebells are well-developed here. Soil either inappropriate for hornbeam or eradicated from this area by man, perhaps in the 1608 clearance (see p.39).

Regeneration: A few young oaks but these are sparse.

Work required: More time should be allocated to removing Himalayan Balsam as it is widespread in this area and is spreading rapidly.

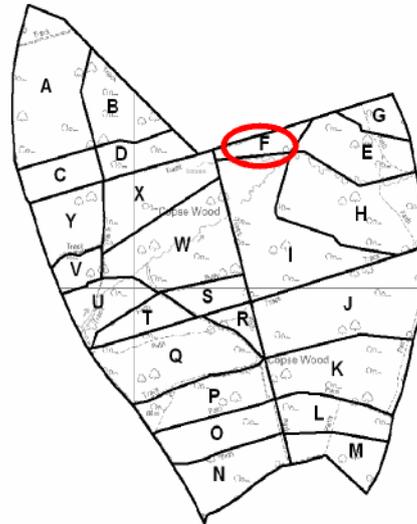
Compartment F

Description: Dense birch-oak-bramble thicket area which has been long-neglected, with hawthorn and hazel near the stream. Good development of honeysuckle overgrowing other shrubs and also much Wood Sorrell (Oxalis acetosella) near the stream.

Regeneration: None noted; shade from brambles too dense.

Work required: Due to its varied nature and botanical interest care is required when thinning. The hornbeam in the north-west part could be singled or coppiced and more light could also be admitted to the stream margins to encourage the growth of flowers. This action was recommended in both the NVC 11 survey carried out by Land Use Consultants in 2006 and the original Long Term Management Plan in 1981 /82.

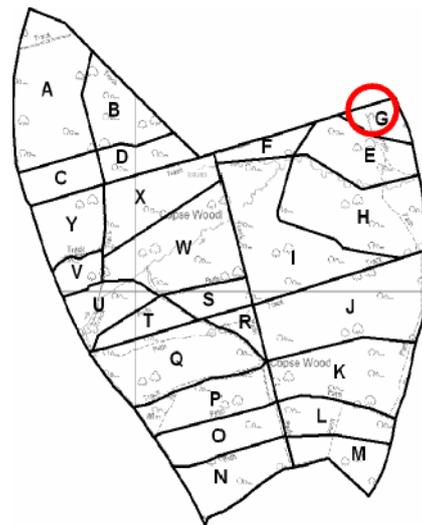
Compartment G

Description: Mainly birch (large specimens of both species) with some sparse oaks and brambles below, also some uncoppiced hornbeam trees and bracken below in parts; especially important for the abundance of bluebells.

Regeneration: The birches are mixed in age, and re-establishing, but there are also old dead standing trees. There is little other regeneration although a few oak seedlings were noted.

Work required: Probably best left to develop on its own but periodic light thinning of the trees other than the birches is recommended if these develop to such an extent that the growth of the birches is depressed. Himalayan Balsam is a problem in this area so should be pulled yearly at least.

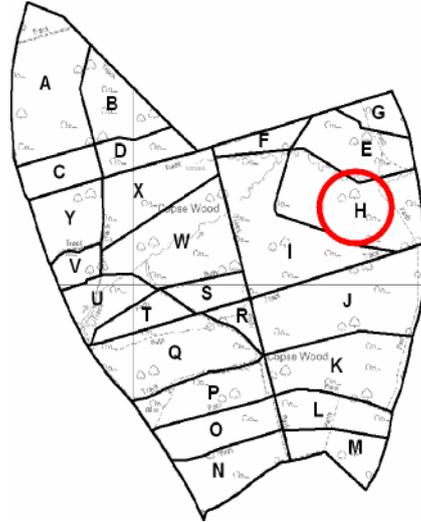
Compartment H

Description: Rather open birch-oak with a dense bracken sward below over much of the area though with hornbeam to the south. The margins of the stream along the northern boundary also support aspens and are especially rich in flowering plants and shrubs. Rowan was reported by Crooks C1970).

Regeneration: There are an acceptable number of young oaks scattered through the area and birch is regenerating locally.

Work required: Light thinning around the stream. Path widening along R70.

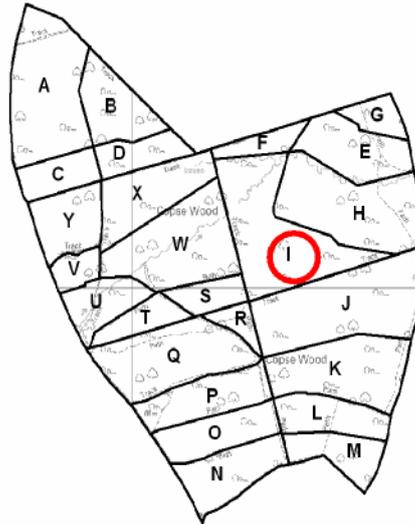
Compartment I

Description: Long-neglected oak-hornbeam coppice with many very old stools and a good number of standard oaks. Some hornbeam trees are present in the northern part. The ground is devoid of vegetation through most of the unit but brambles occur in places and bracken has invaded in others (especially in the south).

Regeneration: Some regeneration of oak has taken place where stools have died. Regenerating holly was noted by Crooks (1970) and is a conspicuous feature.

Work required: Some opening up of small areas around the stream should be carried out. Path widening to be carried out on R70.

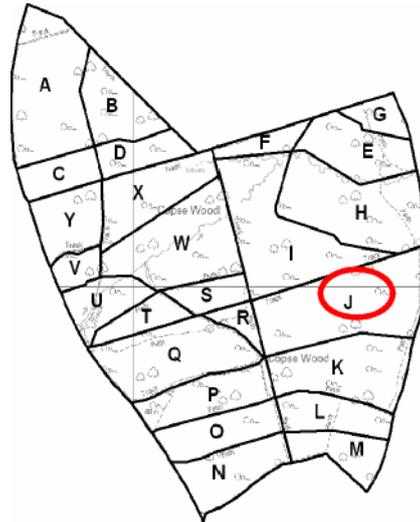
Compartment J

Description: Oak-hornbeam coppice with little ground vegetation except where clearing and replanting was carried out in 1971. Many stools rotten and dead.

Regeneration: Good hornbeam regeneration near some open areas adjacent to the 1971 clearings, also some birch and bracken establishing in these marginal parts.

Work required: Coppice areas marked in orange. (See appendix 2 map 6). Continue to scallop and widen R70 on rotational basis.

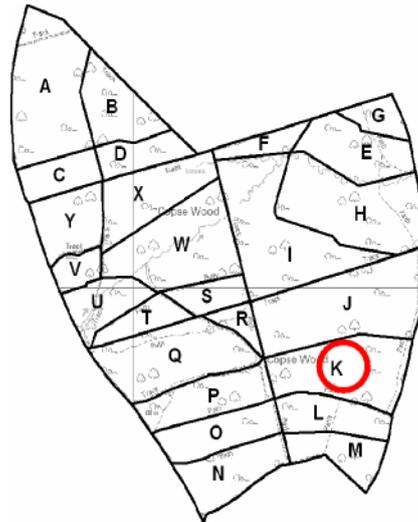
Compartment K

Description: Oak-hornbeam coppice, mostly badly neglected, apart from one area coppiced in 1951/52 (Fig. 6). Some bramble in parts but most with little ground vegetation. Many stools rotten and some have fallen to create clearings where regeneration is occurring. The northern section of one of the 1971 clearings is to the east end of this unit (see p.46). In July 1953 the largest shoots on the 1951/52 coppiced areas were 1.5m (5 ft), with about 50 birch seedlings per square ft, and with rose-bay willow herb and Holcus grasses and brambles spreading (Mitchell, 1954: 19); Crooks (1970: 32) refers to this as giving then a "weak twiggy re-growth" which he attributed "perhaps to insufficient thinning"; the area was very dense and twiggy in 1981 with many dead branches; no wavers appear to have been left in 1951/52. Observations on the state of this area almost 30 years after treatment contributed to our recommendations as to the coppicing method to be tried in the first instance. This twiggy area is now very rich in mosses.

Regeneration: Regeneration of hornbeam occurs where some stools have died and there are also some young hollies.

Work required: Coppice areas marked in orange. (See appendix 2, map 6).

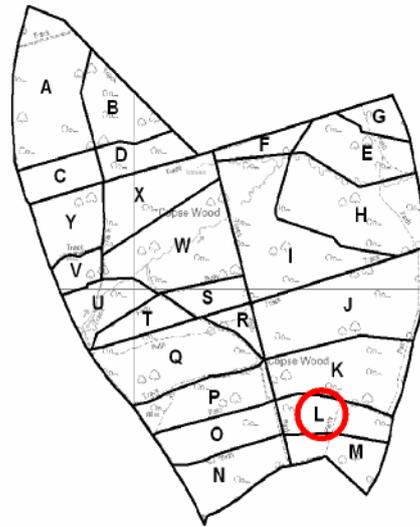
Compartment L

Description: Oak-hornbeam coppice, long-neglected apart from the 1969 and 1971 cleared areas. Many stools rotten. Ground vegetation sparse to absent.

Regeneration: several young oaks in area 4. Possibly 15-20 year old.

Work required: Coppice area marked in orange. (See appendix 2, map 6).

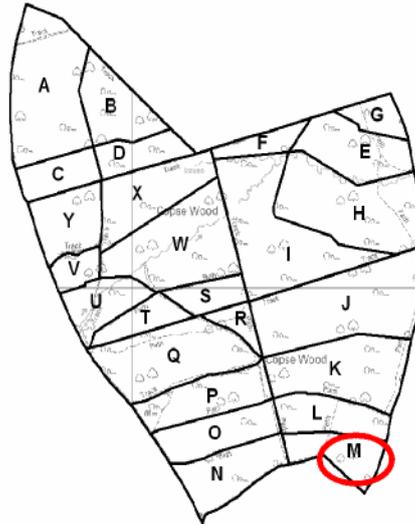
M (excl. 1969 clearing)

Description: Oak-hornbeam coppice, long-neglected, apart from the 1969 clearing. Ground vegetation sparse to absent.

Regeneration: Some oak, holly and hornbeam regenerating particularly where stools have died.

Work required: Coppice area marked in orange. (See appendix 2, map 6).

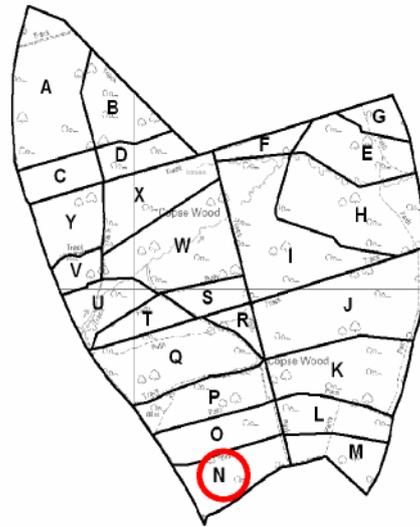
Description: Mainly birch with bracken below, also oaks especially in the north-east adjacent to 0. Also hawthorns, and willows and gorse towards the eastern end, and scrub to the west. An especial feature of the unit is the occurrence of the Twayblade (*Listera ovata*) which has been known here for many years; 200-300 plants of this rare orchid were recorded here in 1955 by Pickess (Kent, 1975:532), but Crooks (1970:32) gave the population as about 50. Wrighton's (1979: 12) indication that it was last seen in 1950 is quite erroneous -- it was still flourishing with about 30 plants seen in 1981. It now appears to be extinct in the Woods.

Regeneration: Little regeneration in the bracken-dominated areas but the oaks present are varied in age. Some sycamore spreading near the southern margin.

Work required: To restore this area to more open heathy habitat by selective thinning of oaks and birch. Bracken should be pulled twice yearly. More scrapes should be created.

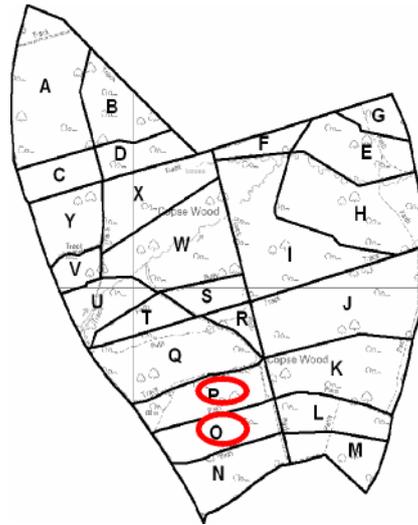
Compartment O+P

Description: The main formerly heath area on the pebbly plateau gravels, the importance of which for flowering plants and insects (especially butterflies) has already been referred to (p.42). It is also of archaeological interest for the furrows still evident (p.39) and the bomb crater in O (p.42). Crooks (1970) considered the decline of heathland plants to be due to the predominance of birch and also noted that the wetter areas were drying out. Today the area is primarily a birch-bracken area (Figs 16-17) with oaks locally regenerating profusely; some old hawthorns (a sign of secondary woodland), sweet-chestnuts (near the bomb crater in O and also in P), willow (by the bomb crater in O), and an ancient larch perhaps relict from the former plantation in the area (see p.39). Part of P was burnt in 1976 and here the moss flora is rich. Scrub is developed along the western margins. Sycamore is becoming quite thick and invasive in parts.

Regeneration: Oaks, and birches regenerating, also sweet chestnuts, hawthorns, and more rarely holly. Most of the oaks are less than 20 cm diam.

Work required: Remnants of a more open, heath area can still be found here, for example there is still a few gorse bushes hanging on and one small area of ling. It is therefore an ideal area for creation of acid grass/heathland. It has also been recommended as an appropriate area for adder introduction by LEHART.

In order to open the area up and make suitable habitat for adder introduction 50% of the birch and oak should be taken out. Bracken should be pulled twice yearly and cuttings raked and used for habitat piles. A few small areas of bracken would benefit woodcock so should be left. One acre per year, starting in area nearest Battle of Britain House would be recommended. A screen of trees and shrubs should be left on R71 to prevent the public and their dogs from disturbing the wildlife. All cut timber should be cut left for tidy habitat piles.

Small scrapes should be made in other sections to encourage heather growth.

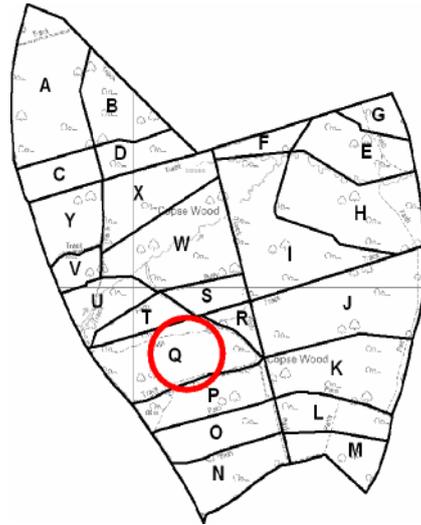
Compartment Q

Description: Birch and oak with bracken in parts and a great deal of dense aged hawthorn and brambles making much of the unit difficult to penetrate; some self-seeded hornbeam on heavier soils, also willows near the site of the old Ranger's Hut. The "Fire-break" track at the Q/R boundary is especially moist and important for flowers preferring such habitats.

Regeneration: Oak is regenerating well in the more open areas, but much of the birch is old. Also developing are young hollies, one yew, and even beech and hazel.

Work required: Removal of conifers and holly where it is a problem.

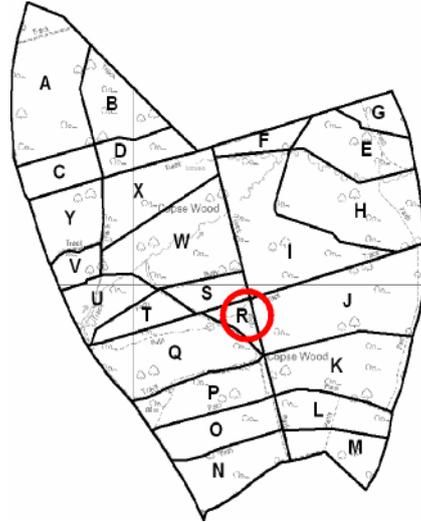
Compartment R

Description: Very similar to Q and conveniently treated with it, it is also part of the formerly cleared area and not ancient hornbeam coppice. Mainly rather dense birch-bracken-oak-hawthorn with young hollies much is difficult to pass through easily. There is a massive coppiced oak in the south-west corner near Q.

Regeneration: Regenerating oak and hollies, also some hornbeam, and hawthorns.

Work required: Light thinning by removal of yew and holly. Create scallops along R73.

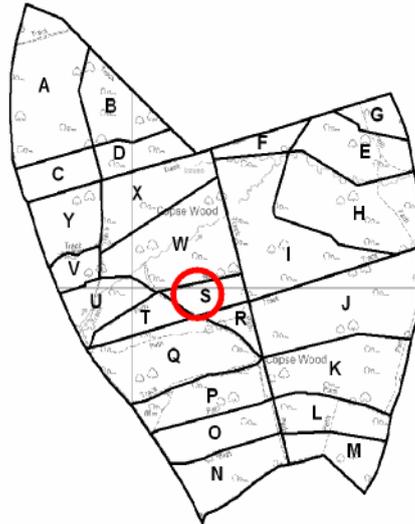
Description: Long-neglected oak-hornbeam coppice, some invading birch, little ground cover except brambles in parts. Also some hazel in the east, sallows in the south-west, field maple in the east, and (according to Crooks, 1970) pollarded ash on the western side. Includes a locality for the Common Cow-wheat (*Melampyrum pratense*).

Regeneration: Little; oak and hornbeam near the eastern limit path, also scattered hollies.

Work required: Create scallops along R69.

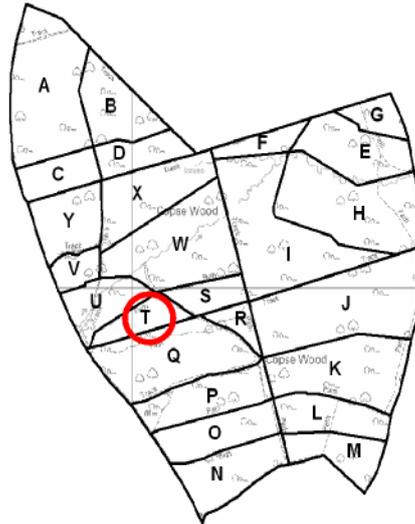
Description: Long-neglected oak-hornbeam coppice, with some old hawthorns (both species) near the southern edge. Also invading birch and bracken in a few places. The ground flora is poor or with brambles/honeysuckle (the latter especially luxuriant in the east). Much of the hornbeam in a rather poor state with dead stools and dead standing poles.

Regeneration: Almost none except immediately by paths. There are few young hollies.

Work required: Continue to coppice long neglected hornbeams.

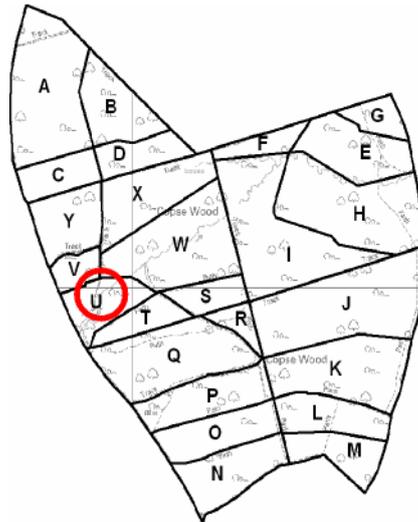
Compartment U

Description: Long-neglected oak-hornbeam coppice except for a cleared strip parallel to Duck's Hill Road continuous into V. Old hawthorns render part very scrubby and difficult to penetrate. A stream runs through this unit and alongside it there are elder thickets near the south-west/north-east path junction. A single alder buckthorn (important for butterflies; see p.42) is present near the south-west corner and there is also a coppiced ash near the road. Strip marshy and important for sedges etc.

Regeneration: A wide range of trees regenerate in the cleared western area but little elsewhere.

Work required: Continue to lay hedge along Ducks Hill Road.

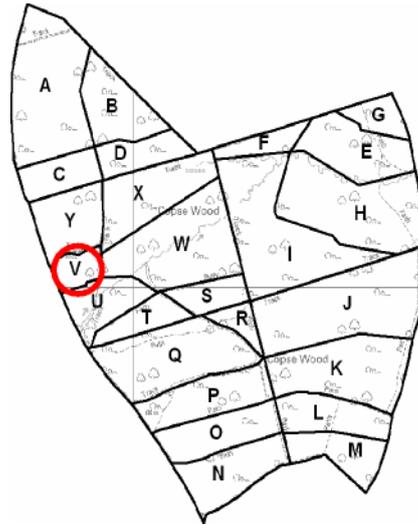
Compartment V

Description: Long-neglected oak-hornbeam coppice with some birch and old hawthorns in parts. Rather similar to U and including a cleared strip near Duck s Hill Road continuous with that in U. This strip rather drier here and almost impenetrable in parts due to prolific regeneration. Some elder and hazel are present. Little ground cover in much of the unit away from the marginal strip where there are brambles and honeysuckle.

Regeneration: A wide range of trees regenerating in the western strip, including an appreciable amount of ash, also some by paths, including hornbeam and oak.

Work required: Continue to lay hedge along Ducks Hill Road.

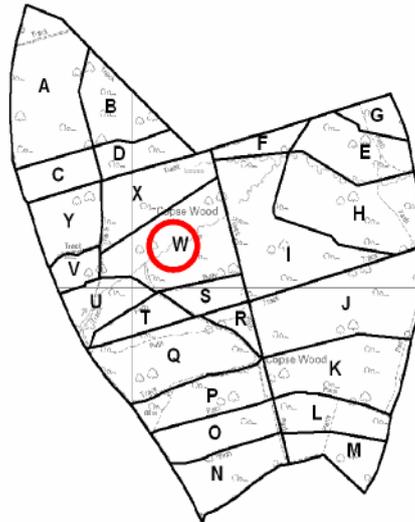
Description: A rather mixed area but mainly long-neglected oak-hornbeam coppice. There is much bracken in the north-western part adjacent to X and birch is especially common here also. A particular feature of the area is the stream running from west to east across its entire length and the valley-like topography., the importance of this for flowering plants has already been stressed (p 42) Maple, crab apple, and hazel also occur along the north-south path through the unit.

Regeneration: Little regeneration except along the path margins or where there has been some gap made in the canopy.

Work required: Thin out holly and yew. Remove invasive species.

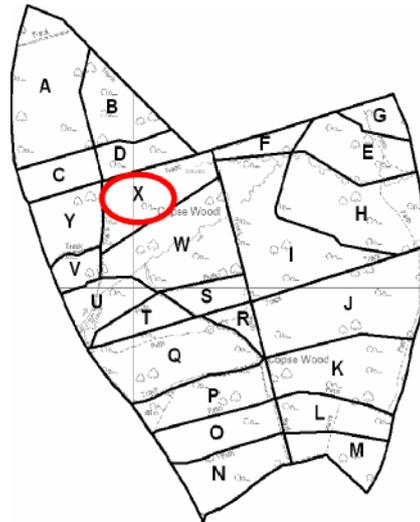
Compartment X

Description: Long-neglected oak-hornbeam coppice, with dead stools and dead branches still standing. Bracken provides the ground cover, especially in the east; birch is scattered throughout, and there are some old hawthorns to the north-east. A small stream with one fork is also present.

Regeneration: Little or none in most of the unit although some hornbeams are regenerating in clearings formed where old stools have died. Some oaks in the bracken area and hollies scattered throughout.

Work required: Thin out holly in this area where it is common.

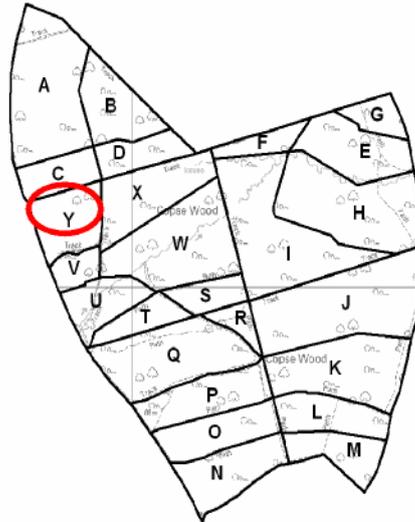
Description: Oak-hornbeam coppice, with scattered birch. Little ground cover through much of the area but brambles, honeysuckle and bracken in parts. An area of about 1.5 acres in the north-west of this unit was treated in about 1972 by the reduction in the numbers of poles on each hornbeam stool. This has made this small area much easier to walk through and more attractive than some other parts of the coppiced areas but failed to overcome the problem of regeneration, the adoption of such a treatment through the woods, on the basis of the evidence here, would mean in the long term that re-planting would probably be required if its present interest was to be kept -- as a result this method was not endorsed by the Working Party as a satisfactory long-term method of management for neglected coppice. Near the road there are some maples and ash, and the unit also has the Wild Service Tree, rare in the area.

Regeneration: Where stools have died brambles and hollies tending to regenerate (to 2m in places) but there is little regeneration through most of the unit except by the eastern boundary track where oak, hornbeam and birch were found to be regenerating in this better-lit situation.

Work required: Coppice area marked in orange. (See appendix 2, map 6). Continue to lay hedge along Ducks Hill Road.

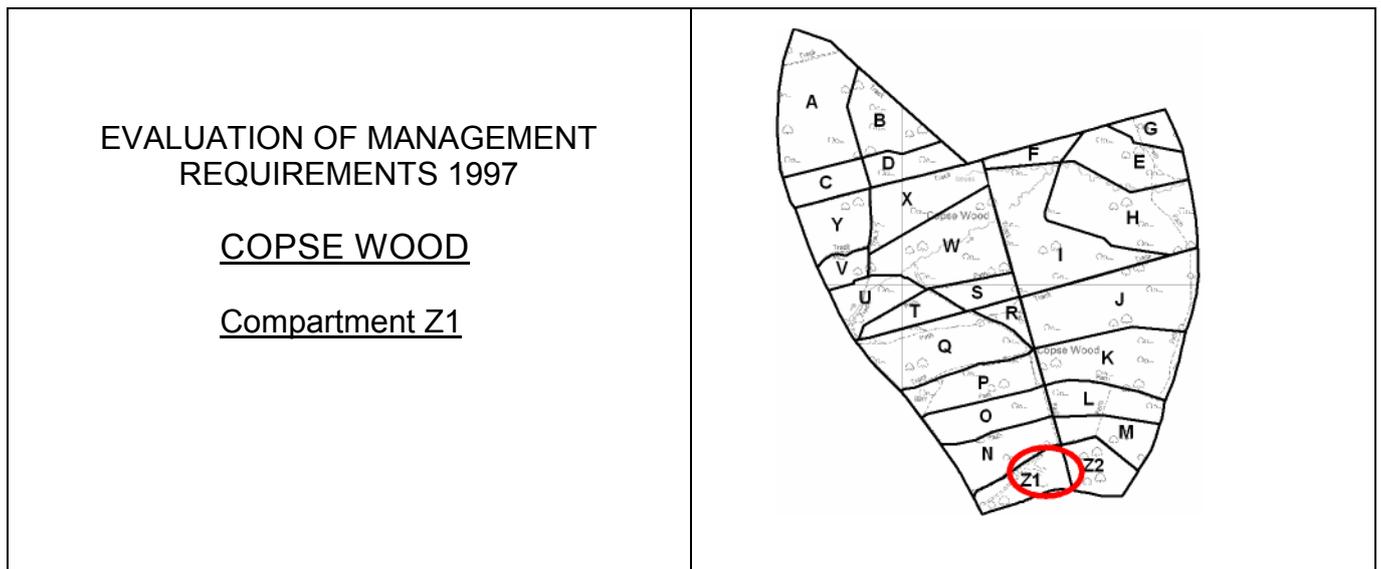
Compartment Z1

Descr.: Relict partially landscaped garden, with several planted conifers and other trees and shrubs, and open oak woodland. Road to former house covered with soil and now grassed over. Dense laurel and rhododendron along northern boundary with Copse Wood. Former lawn invaded with hornbeam, birch, oak and bramble but grass not yet quite swamped.

Regen.: Hornbeam, birch and a few oaks on lawn.

Work required: Eliminate all laurels (these are the source of invasion into Copse Wood). Rhododendrons appear not to be spreading by seed and can be left for future consideration. Remove all planted trees, particularly the evergreens (Cypresses). Prune oaks along southern boundary to reinstate the view described above. Remove scrub from former lawn to maintain open grassy area. Old entrance: remove derelict brick structure. Reinstall the old boundary hedge alongside Duck's Hill Road to eliminate roadside space suitable for dumping.

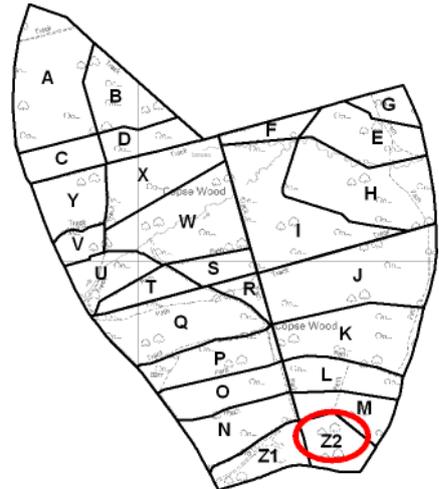
Compartment Z2

Descr.: Hornbeam coppice with oak standards. A few birch holly and laurels. Very little undergrowth.

Regen.: None.

Work required: Z2. Is within the NNR. The hornbeam coppice has gradually shaded out most of the ground-flora particularly within the last sixty years. Coppicing should recommence to rectify this. This should have the added benefit of protecting the colony of English Bluebells from the current trampling by walkers.
